Project Completion Report

Reline of GRP Tank

Alder Hey Children's Hospital - Liverpool

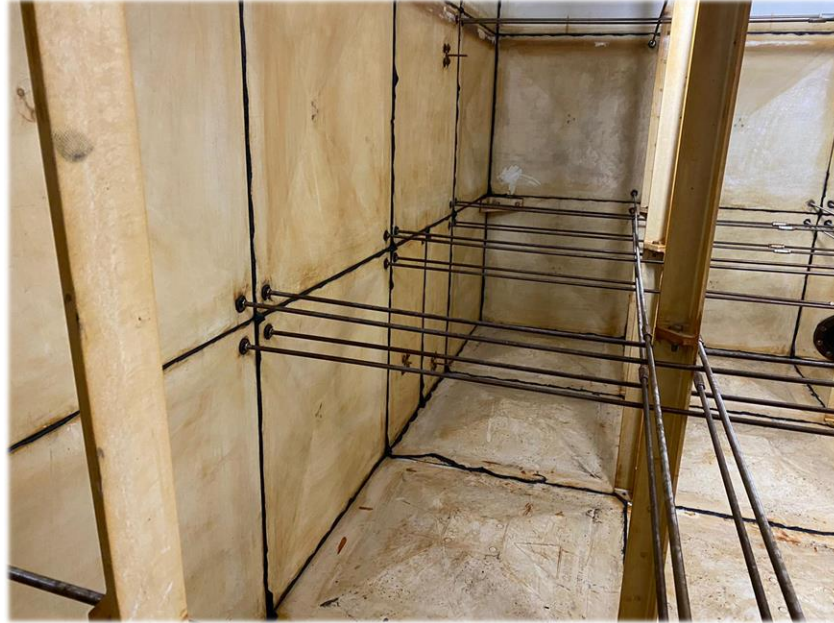
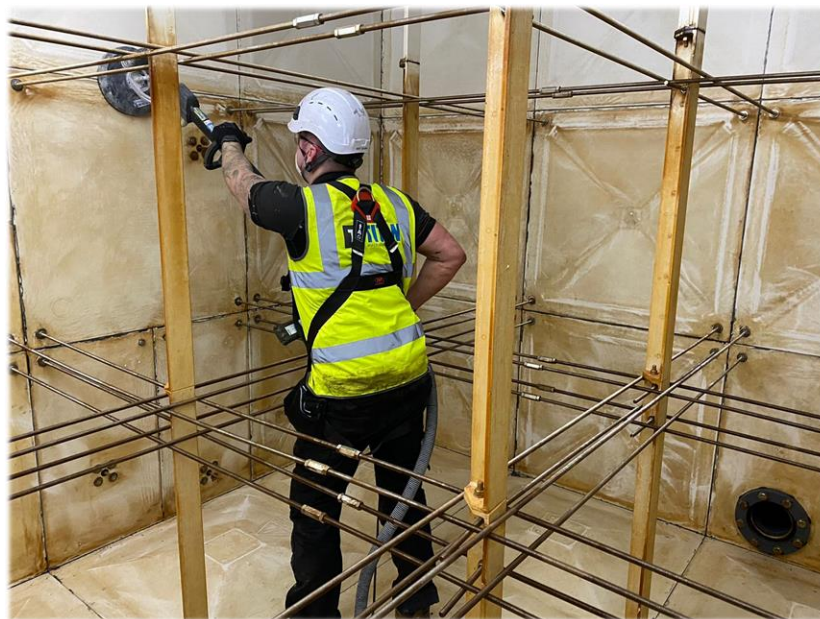
CWST was in poor condition prior to preparation and had heavy contamination along the walls and base.

The photos below show the tank at various stages of the process, from preparation of the surface, (current page) to the final application of the 2nd coat (last page).

- Arrival - Tank to be drained down by Titan Mechanical Services. - **Complete**
- Surface Preparation – All accessible bolts tightened, and mastic joints assessed and repaired where necessary. All surfaces then abraded to raise a surface profile of ~75microns. - **Complete**

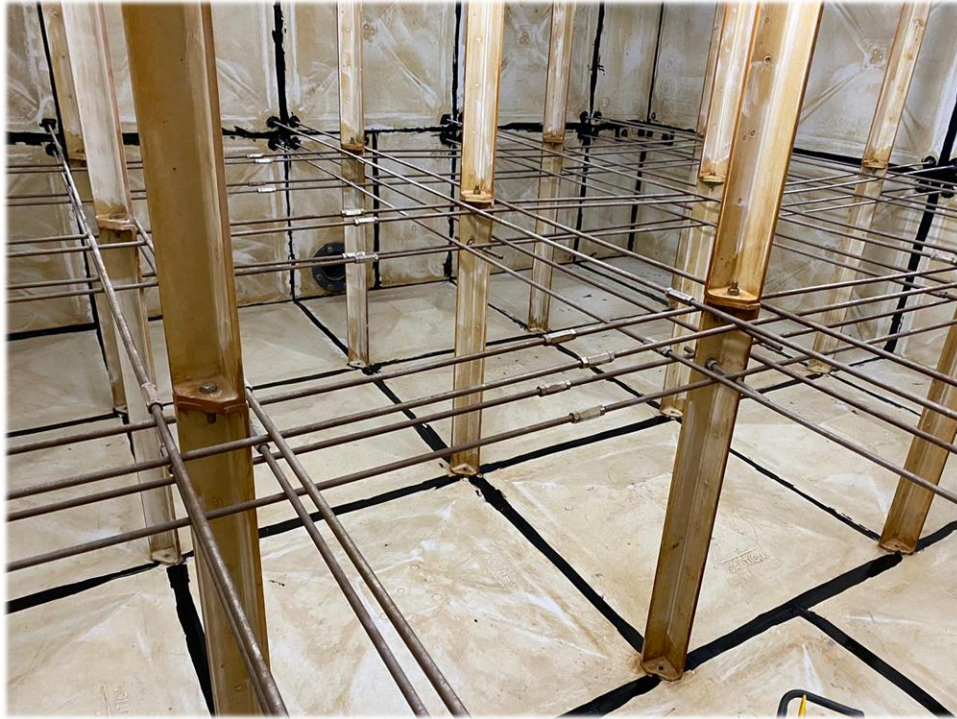
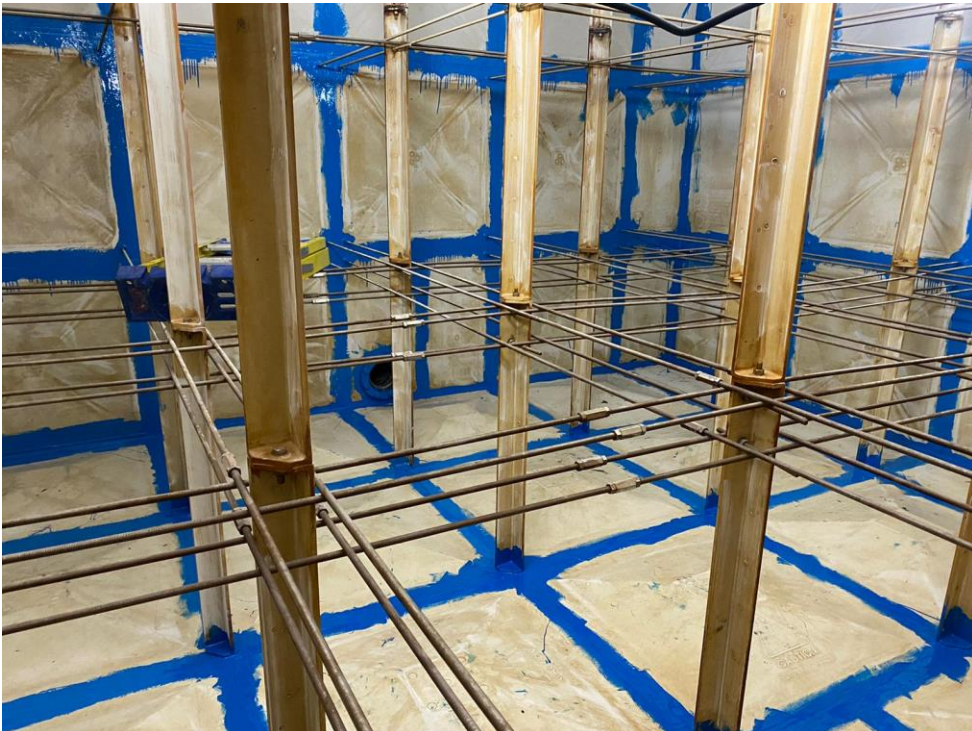
The photos below show sealing of the bandage and application of the stripe coat.

- All joints and connections to be sealed with a fiberglass bandage.
- Solvent free polyurethane coating - Where necessary, dehumidification/heating equipment will be used to ensure correct curing conditions are achieved. The solvent free polyurethane coating is applied by brush or roller to give a uniform even thickness of a nominal 500microns per coat. A minimum of two coats will be required to achieve a nominal specified thickness of 1000microns (1mm). - **Complete**

- Application of Stripe Coat – Product is applied by brush to all joints, edges, bolt heads, struts and other sharp protuberances to ensure any high-risk areas are secured and enable subsequent coating to be a seamless membrane. - **Complete**

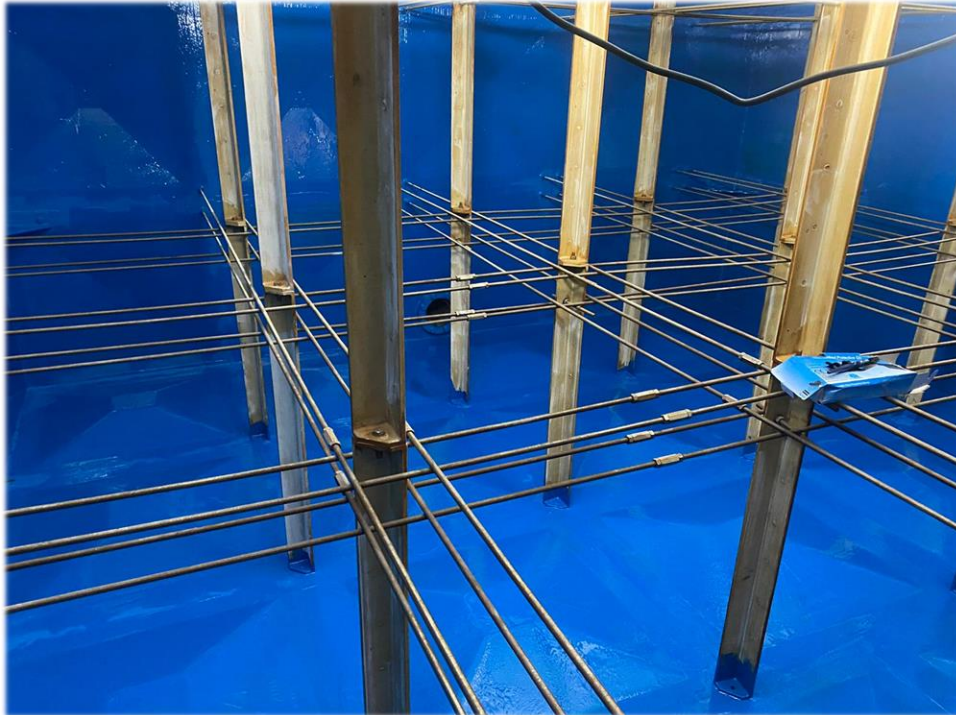
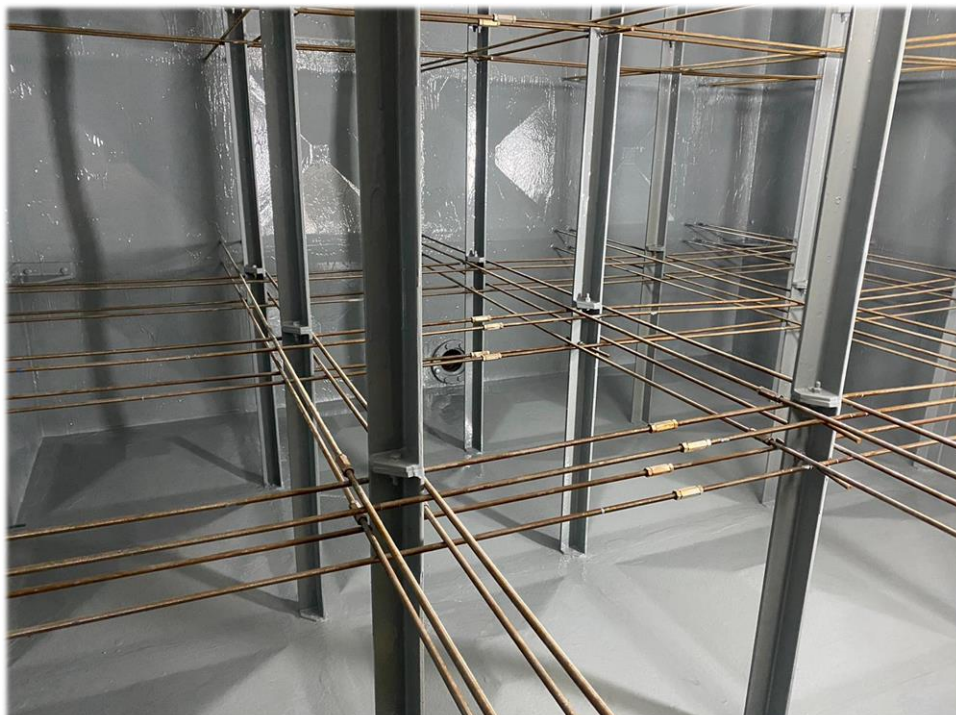
The photos below show the final application of the 2nd coat. A dry film thickness test was carried out during the process, with an average thickness of more than 1000 microns achieved on all surfaces.

- Application of First Coat - Product is applied by roller to all internal surfaces to a minimum 500-micron wet film thickness. - **Complete**
- Application of Second Coat - Product is applied by roller to all internal surfaces to a minimum 500-micron wet film thickness to achieve a desired 1000-micron total coating thickness on all internal surfaces. - **Complete**
