# Project Completion Report

## Reline of Galvanised Steel Tank

### Care Home - London

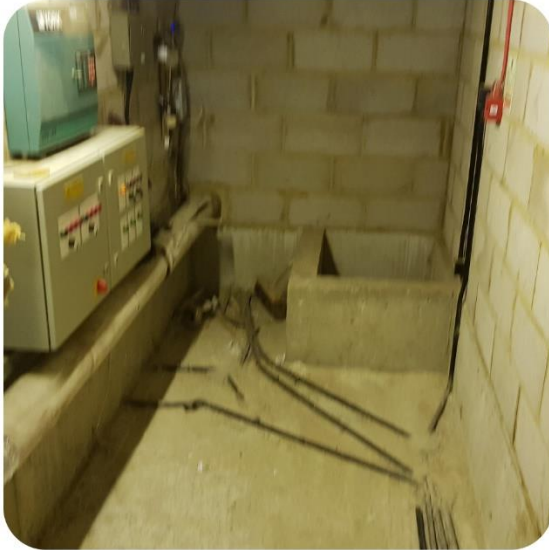
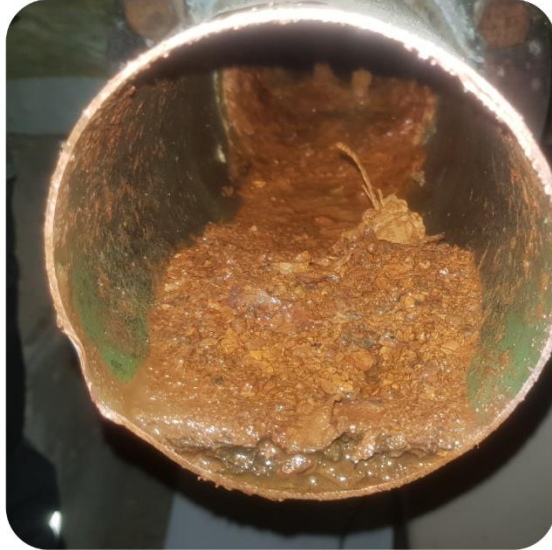
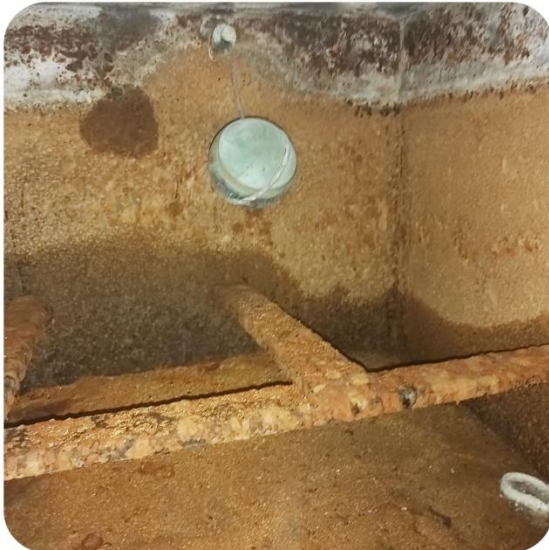
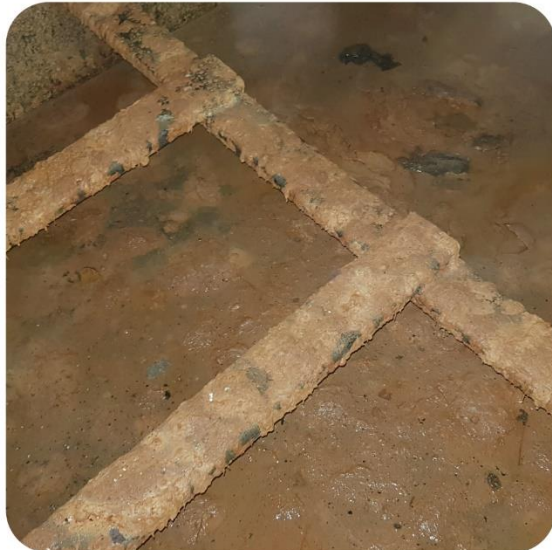
The photos below show the area where the temporary tank would be situated and the condition of the tank and pipework prior to commencement of works:

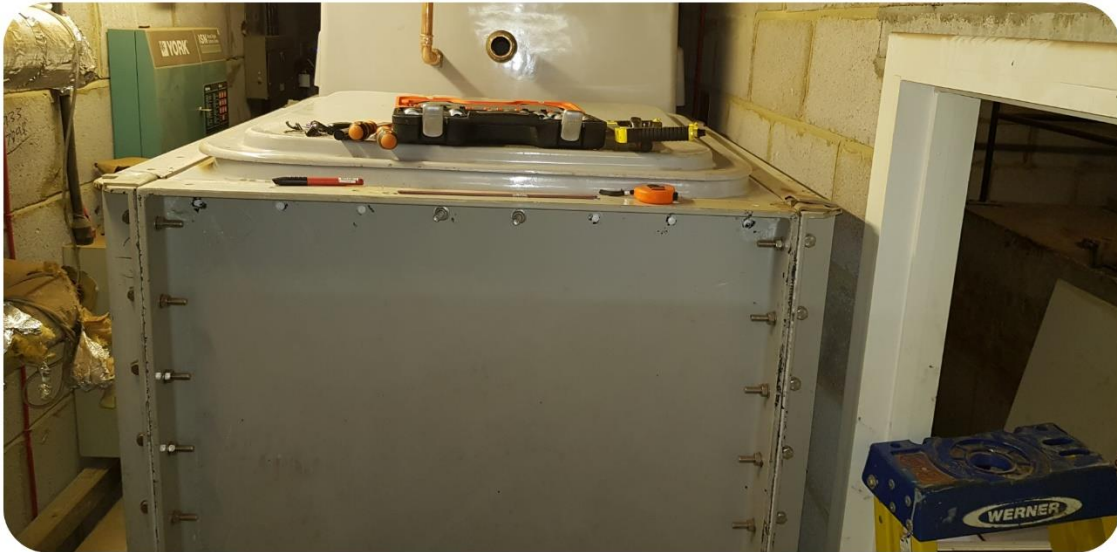
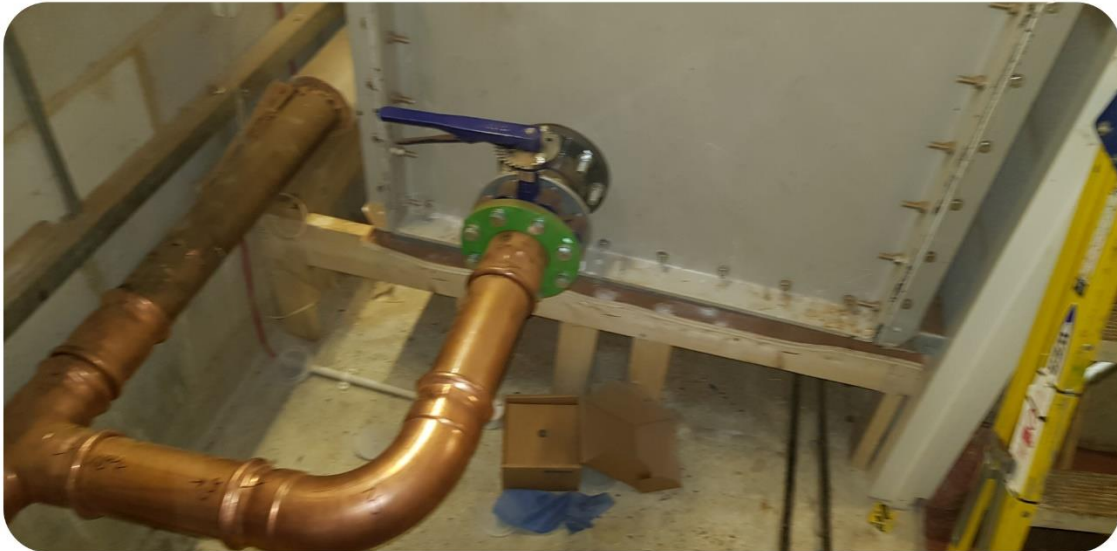
The photos below show the newly built temporary tank and the bypass pipework:

- Upon arrival, a temporary tank with a 4" supply and 2.5" supply to be installed and put on-line for the duration of the works – **Complete**
- Original tank to be drained down by Titan Mechanical Services – **Complete**

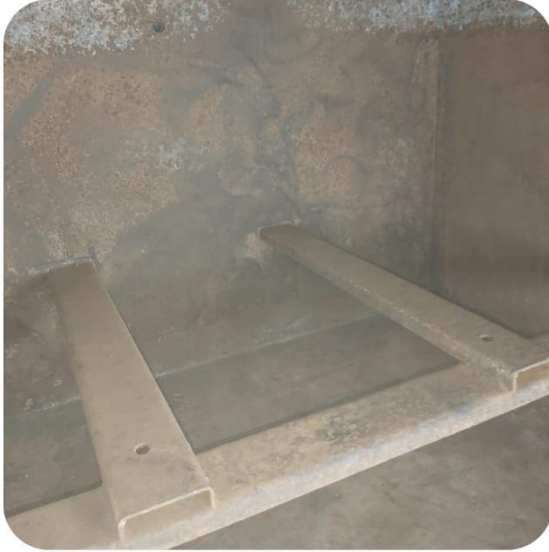
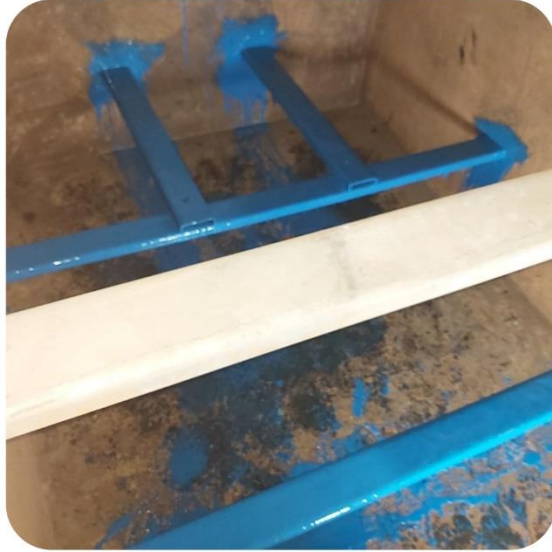
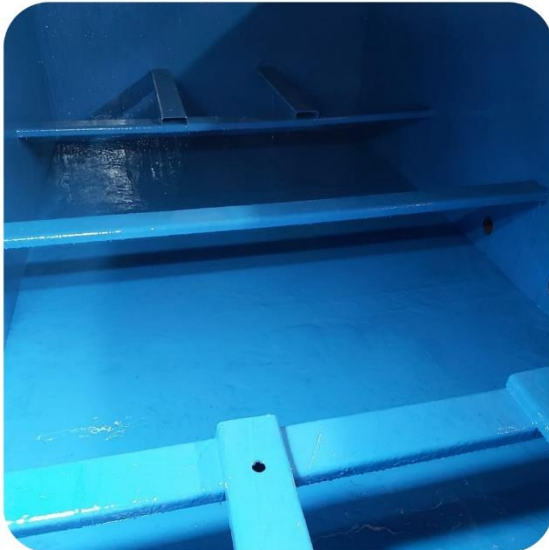
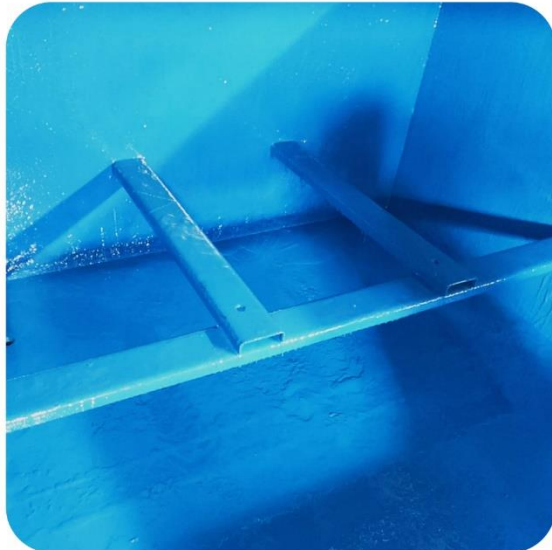
The photos below show the tank once it has been prepped, the stripe coat applied, and the first coat fully applied:

- Surface Preparation, all accessible bolts to be tightened, mastic joints assessed and repaired where necessary. All surfaces will be abraded to raise a surface profile of ~75microns - **Complete**

- Application of Stripe Coat - the product to be applied by brush to all joints, edges, bolt heads, struts and other sharp protuberances to ensure any high-risk areas are secured and enable subsequent coating to be a seamless membrane - **Complete**

- Application of First Coat - the product to be applied by roller to all internal surfaces to a minimum 500-micron wet film thickness - **Complete**
- Application of Second Coat - the product to be applied by roller to all internal surfaces to a minimum 500-micron wet film thickness to achieve a desired 1000-micron total coating thickness on all internal surfaces – **Complete**

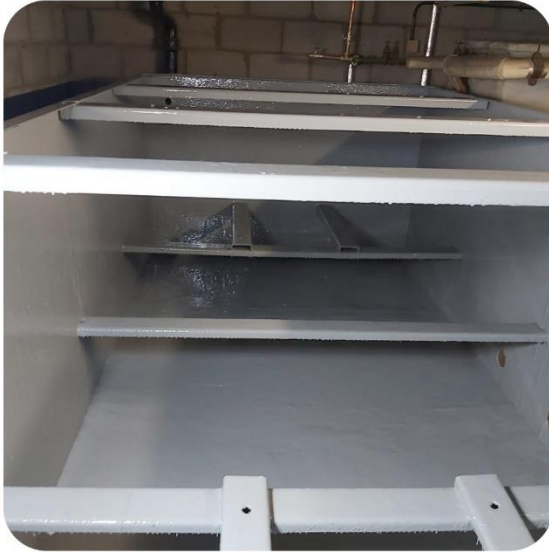
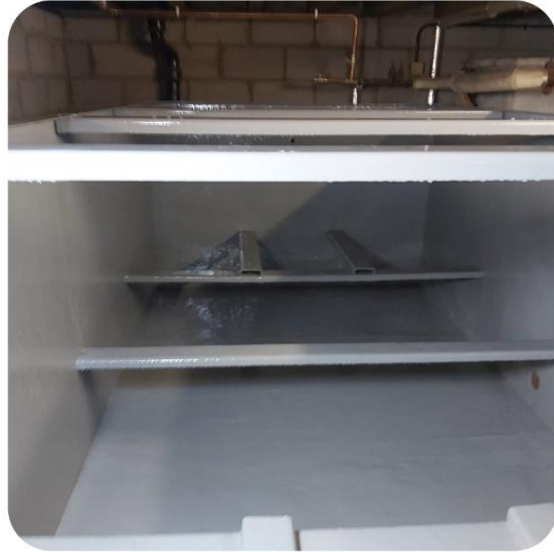
The top two photos below show the tank once the final coat has been applied. A dry film thickness test was carried out during the process with an average thickness of more than 1000 microns achieved on all surfaces. The bottom left photo shows the Keraflo KB valve installed and the bottom right photo shows the vent pipework moved to a tundish.

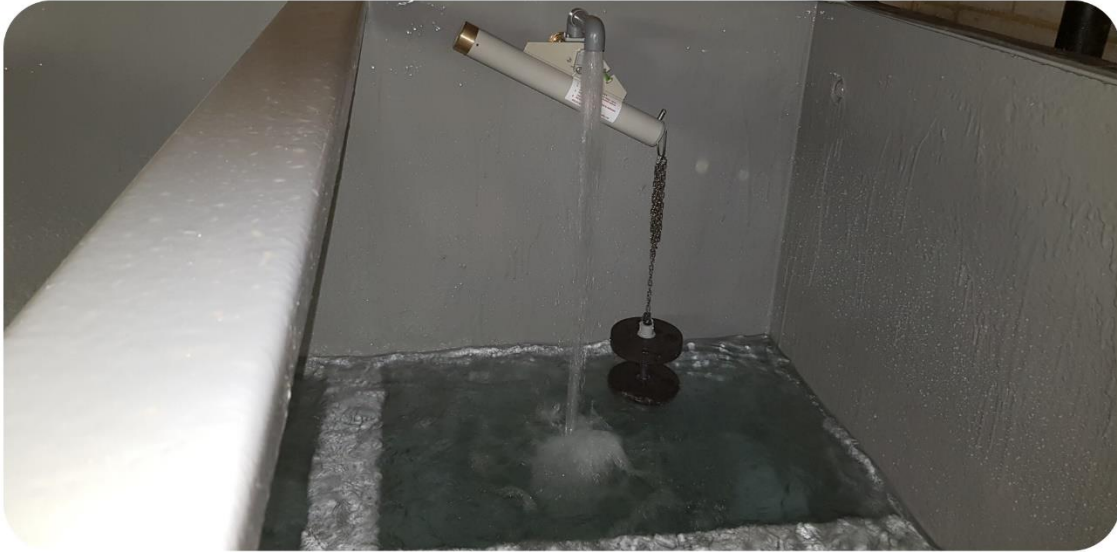
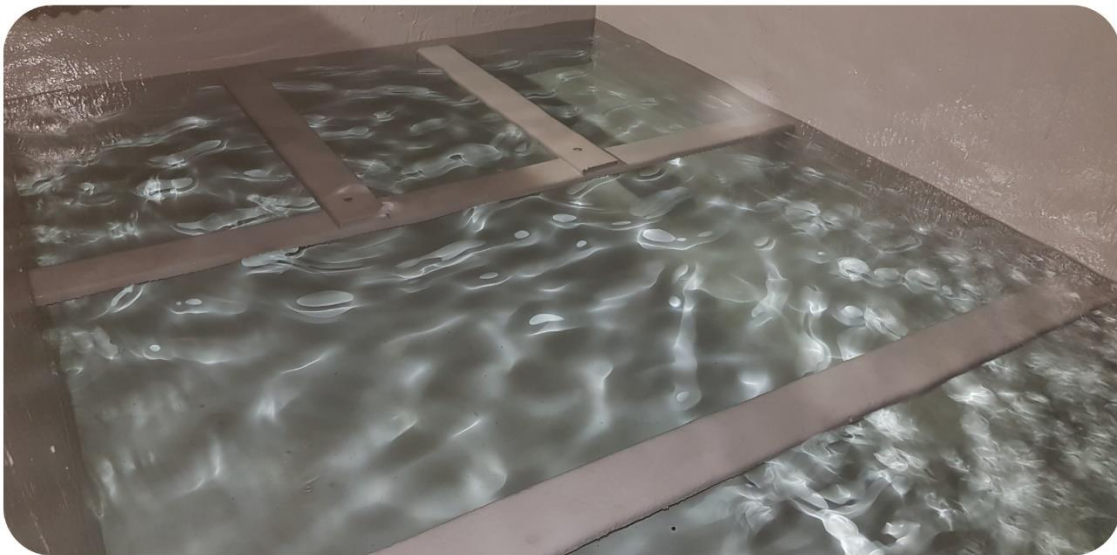
The photos below show the newly relined tank, recommission and back in service:

- Re-commissioning of the tank - upon completion of works, the tanks will be refilled and disinfected in accordance with the requirements of PD855468:2015, before being returned to service - **Complete**

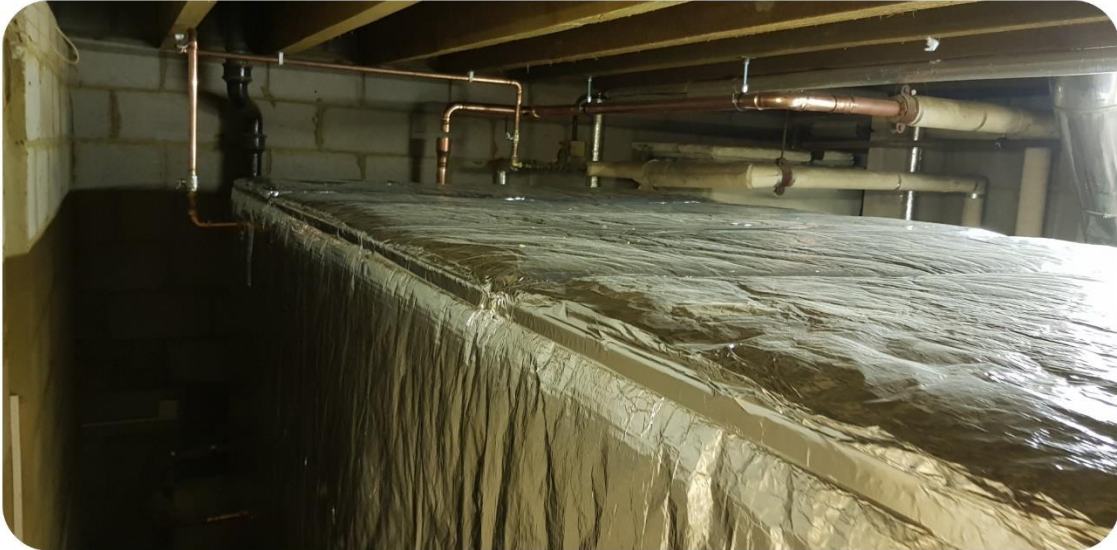
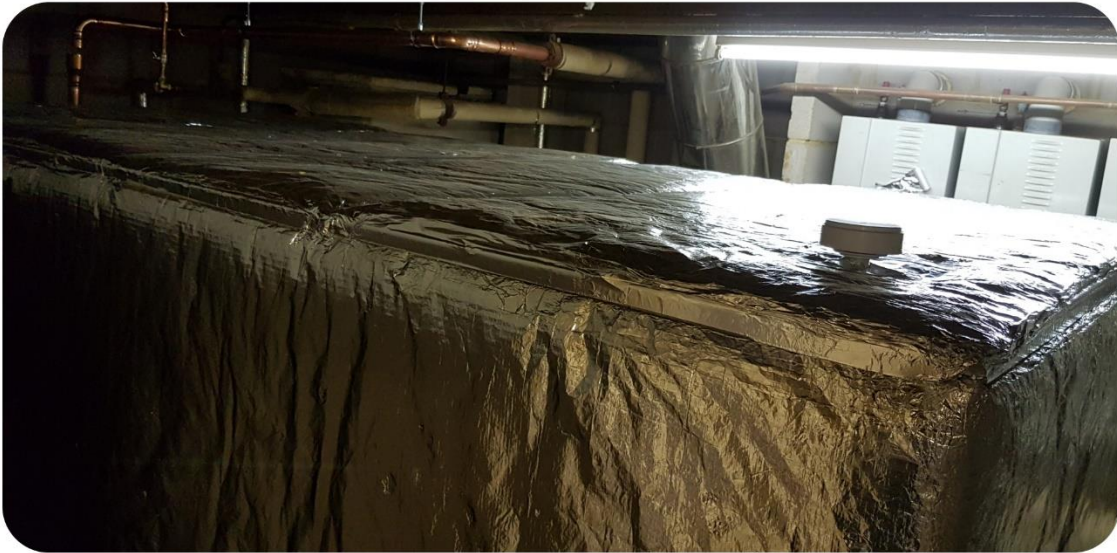
The photos below show the newly insulated tank and with a new lid vent installed:

- New insulation and screened lid vents to be installed to cold water storage tank – **Complete**
- Overflow to be installed – **Complete**
- Existing 2" float valve to be replaced with a new Keraflo KB valve to allow adjustment of water level - **Complete**
