Project Completion Report

TR2176

Office Building

Reline of Sprinkler Water Tank & Associated Mechanical Works

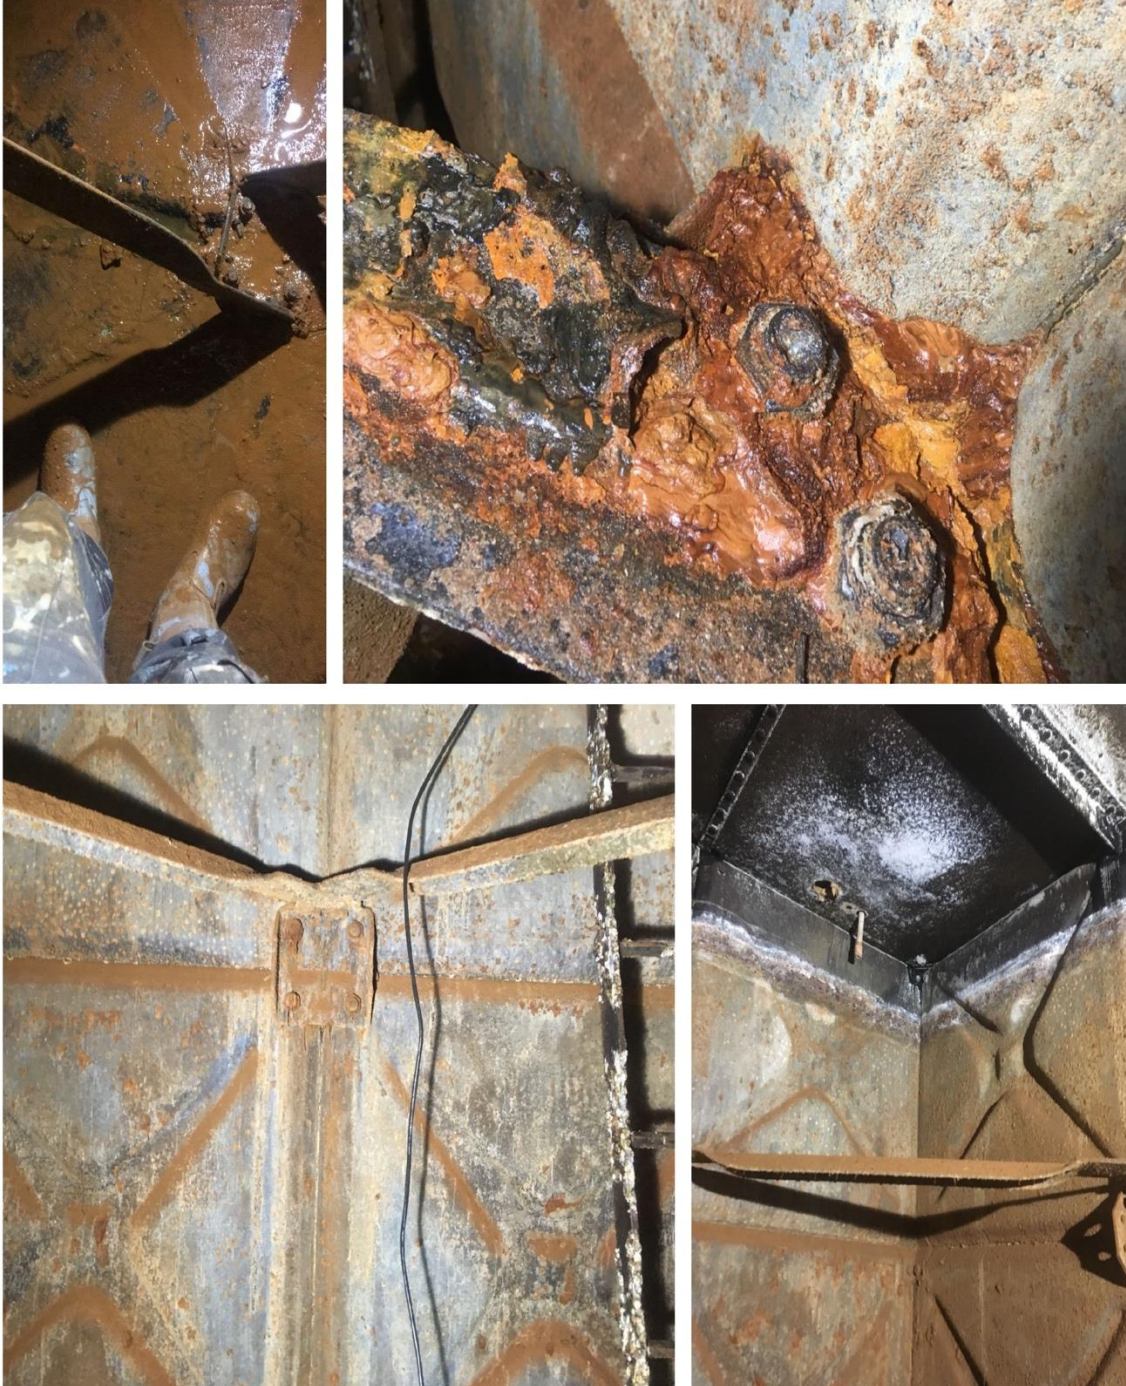
Condition of Tank Prior To Commencement of Works

Sprinkler Water Tank was in poor condition prior to preparation and had heavy internal corrosion along the walls and base.

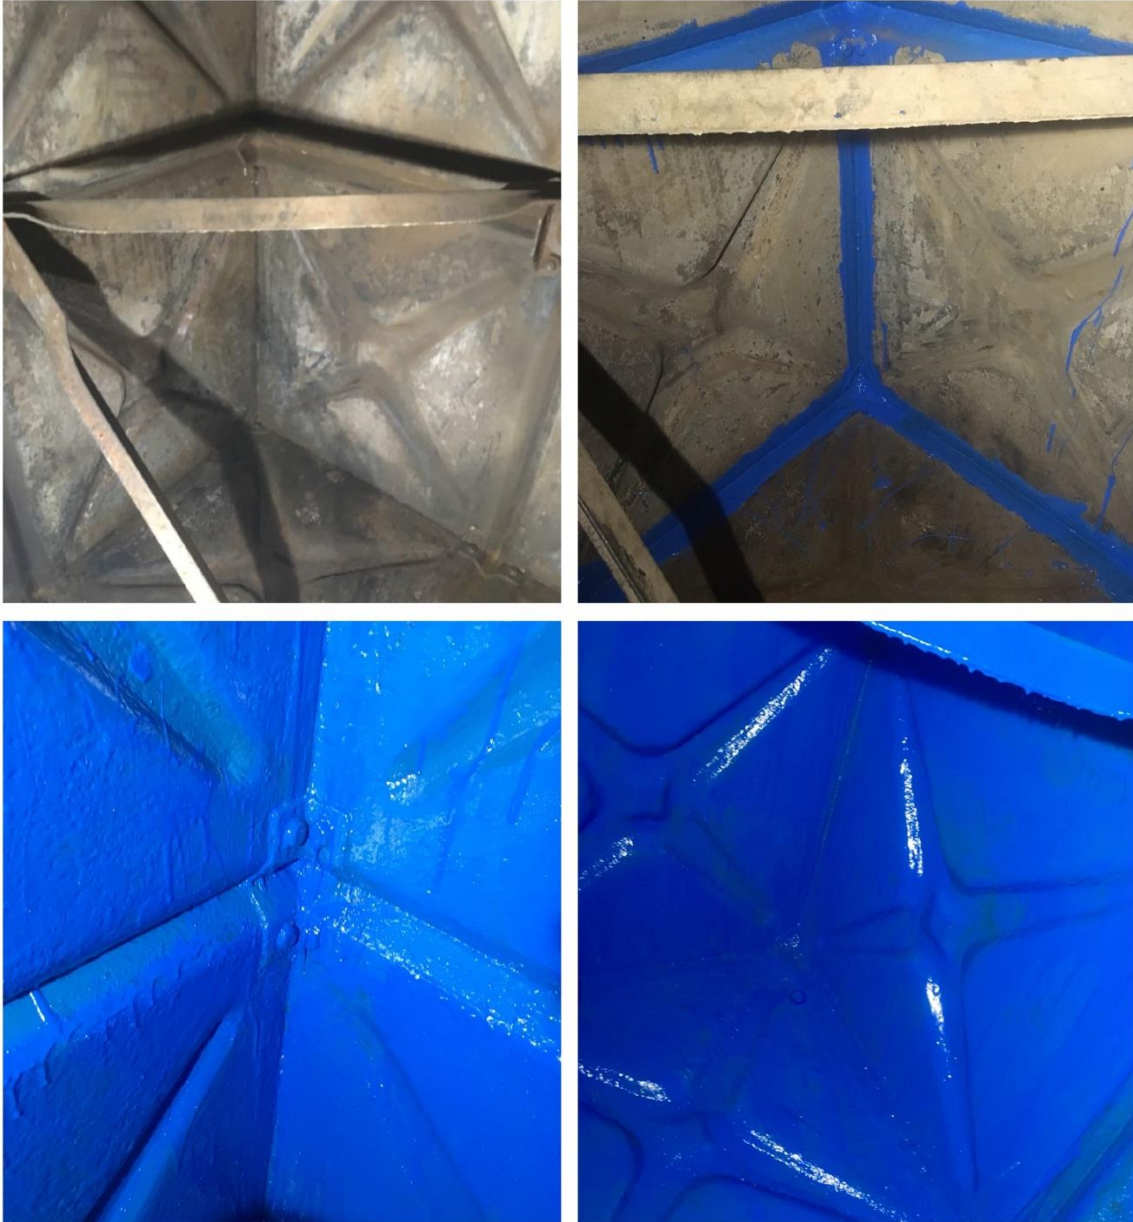
Relining Process

The photos below show the tank at various stages of the process, from preparation of the surface (top left), to the application of the 1st coat (bottom right).

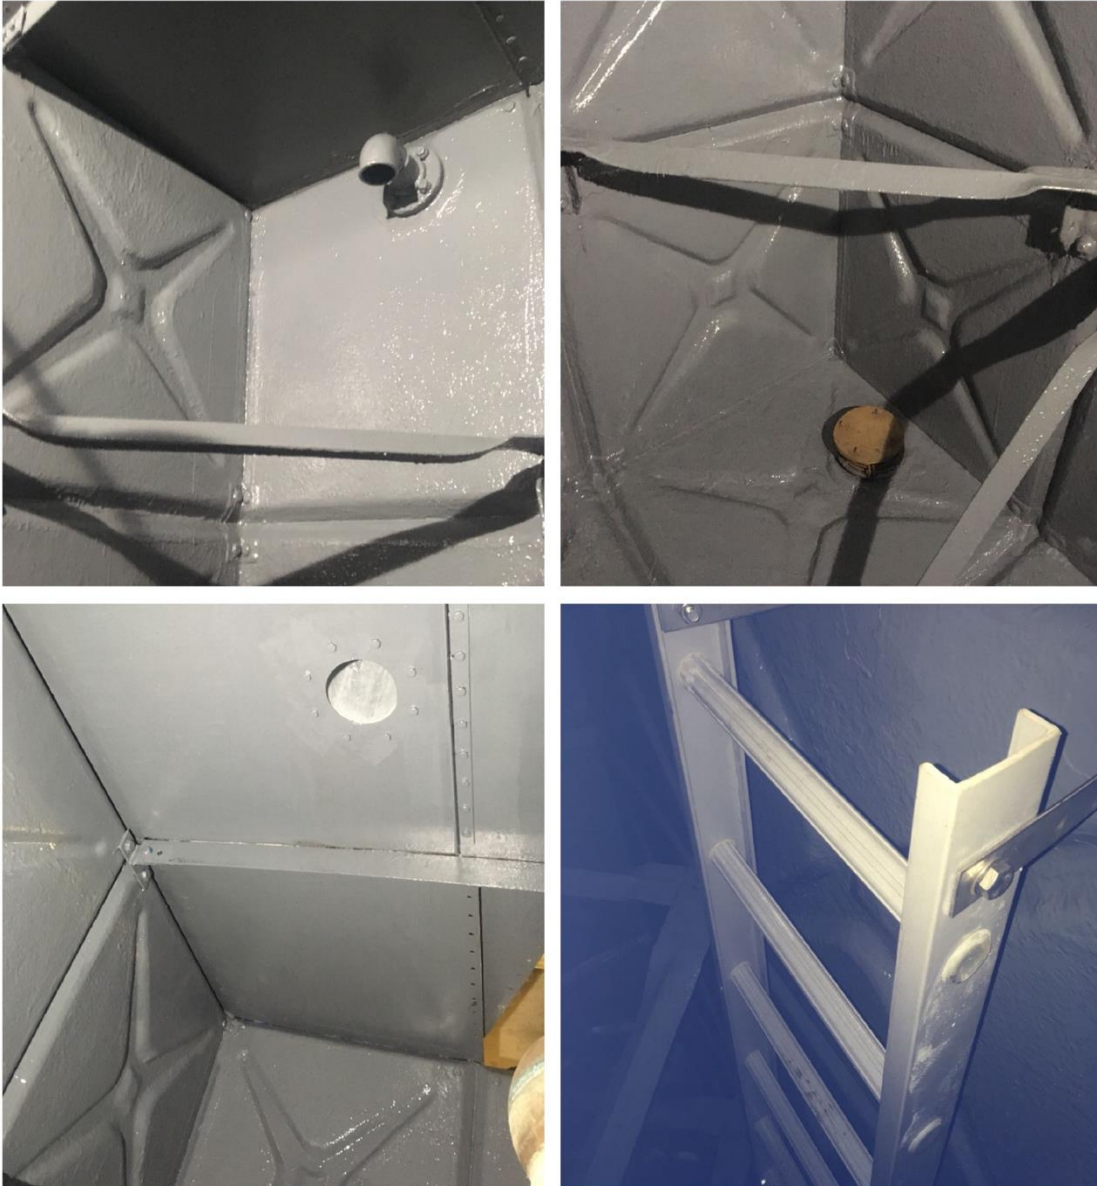
Final Coat

The photos below show the tank after the final application of the 2nd coat, and the new GRP ladder replacement. A dry film thickness test was carried out during the process with an average thickness of more than 1500 microns achieved on all surfaces.
