# Project Completion Report Legionella Remedial Works Care Home, Bristol

**Site name:** Care Home, Bristol

**Scope of Works:** Various water system remedial works following recent Legionella risk assessment.

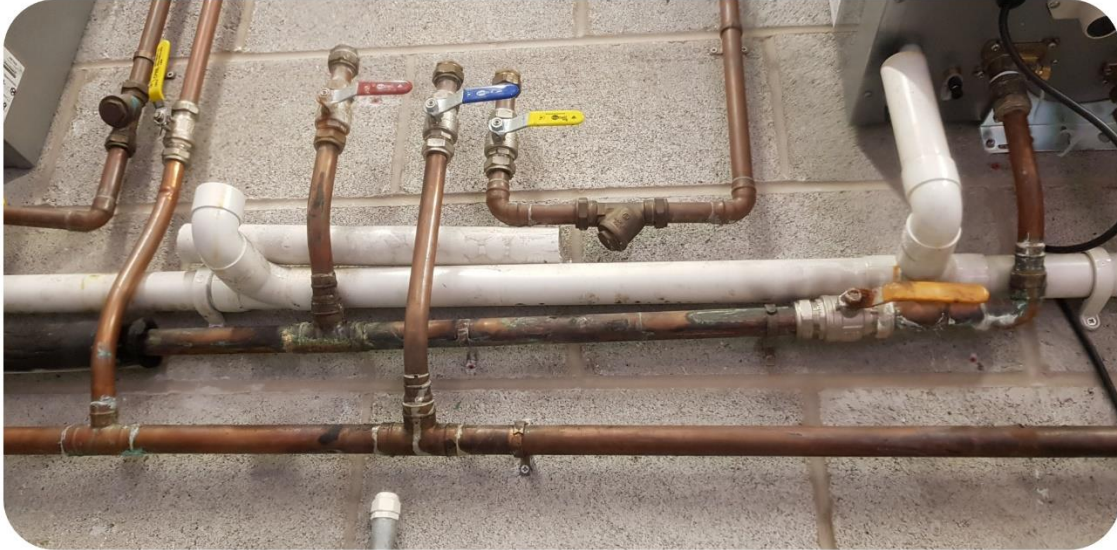
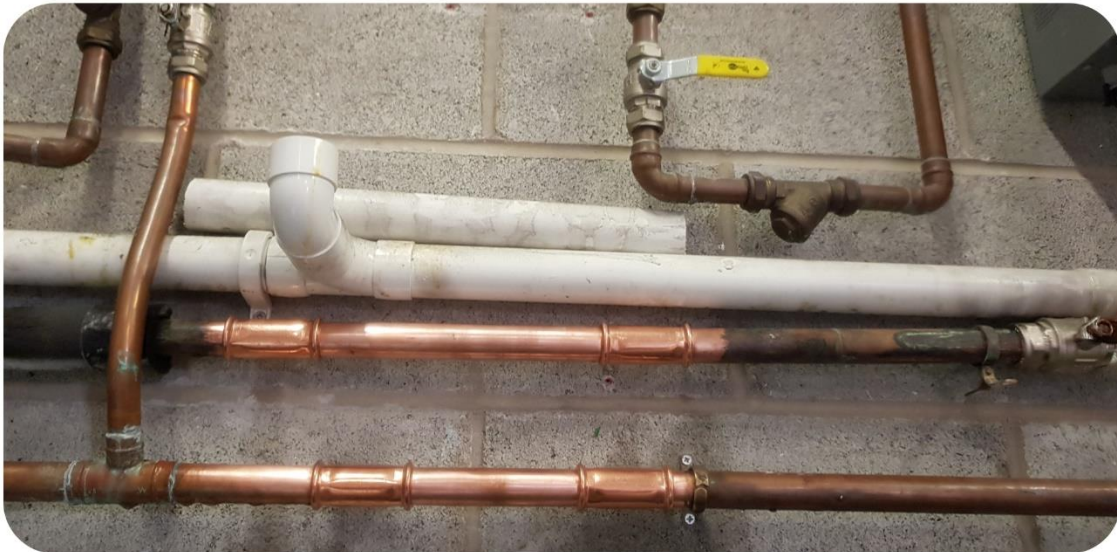
Before and after dead-legs are removed:

- Any dead legs should be engineered out of the system or cut back and capped off as close as possible to the live source - **Complete - 3 dead-legs removed**

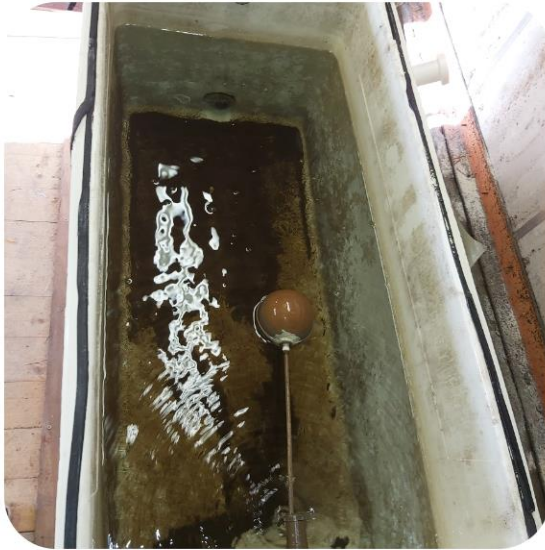
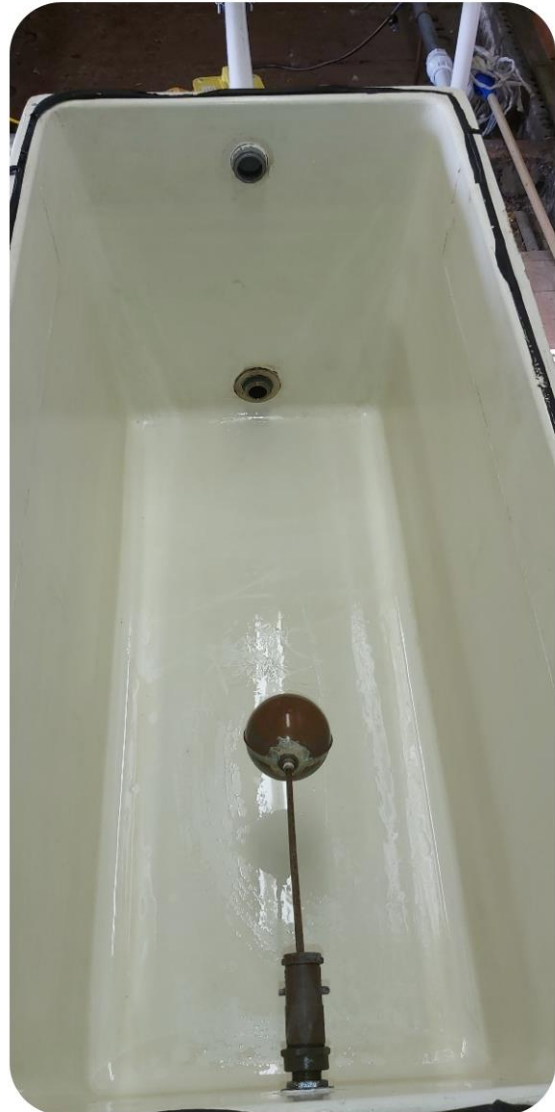
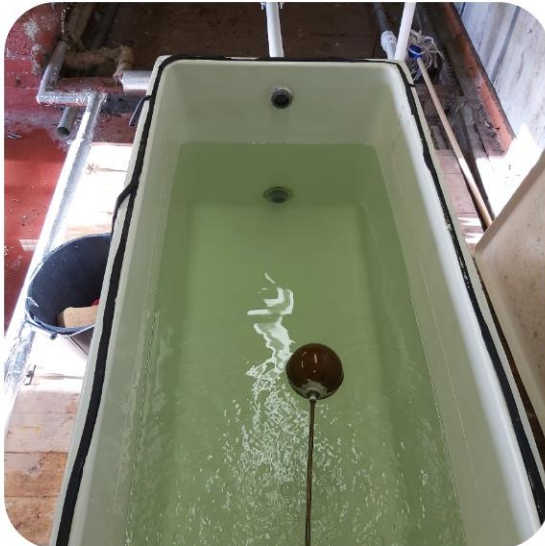
Before and after of CWST1 being cleaned and disinfected:

- Reorient expansion vessel linked to CAL 2, to ensure it is in a vertical position – **Complete**
- Clean & disinfect CWST1 – **Complete**
- Insulate all cold-water pipe work – **Complete - 23 meters insulated**

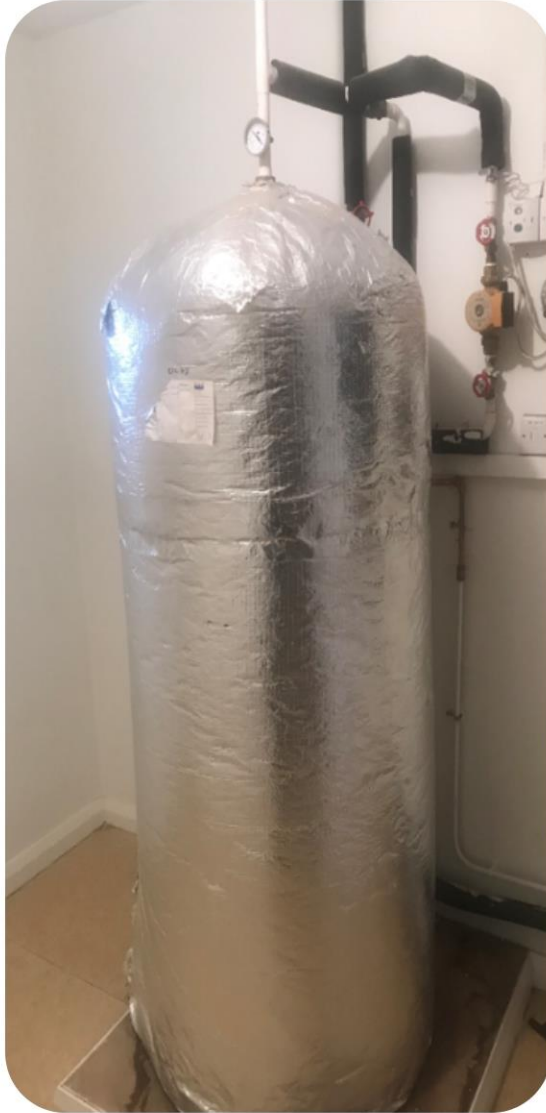
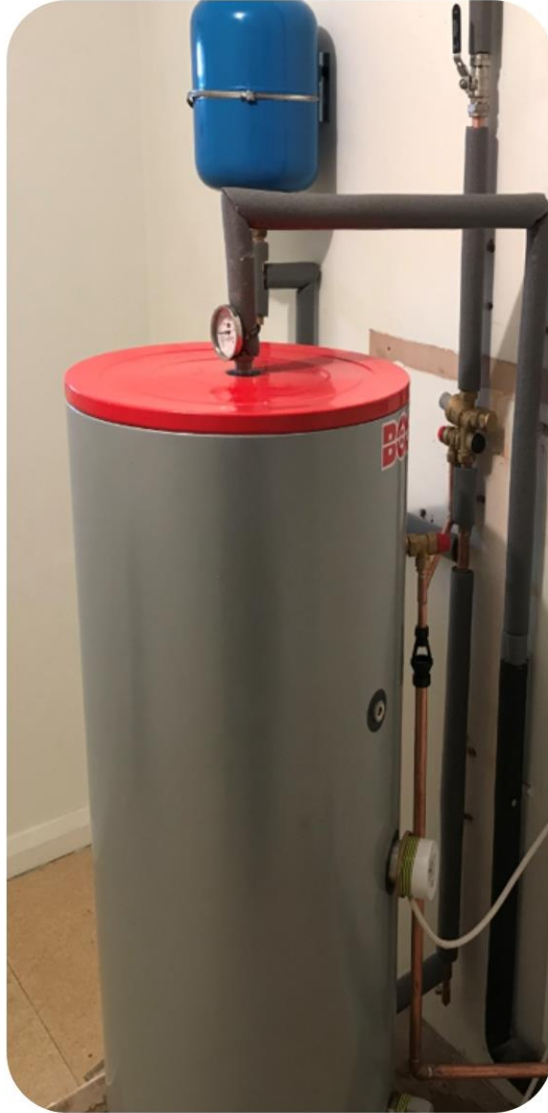
Before and after CAL1 is replaced with new 200ltr unvented mains fed system:

- Elevate/lower stored temperatures so that CAL1's stored and flow temperatures are as close to 60°C as possible and return temperatures at least 50°C – **CAL1 beyond repair, new unvented cylinder installed**

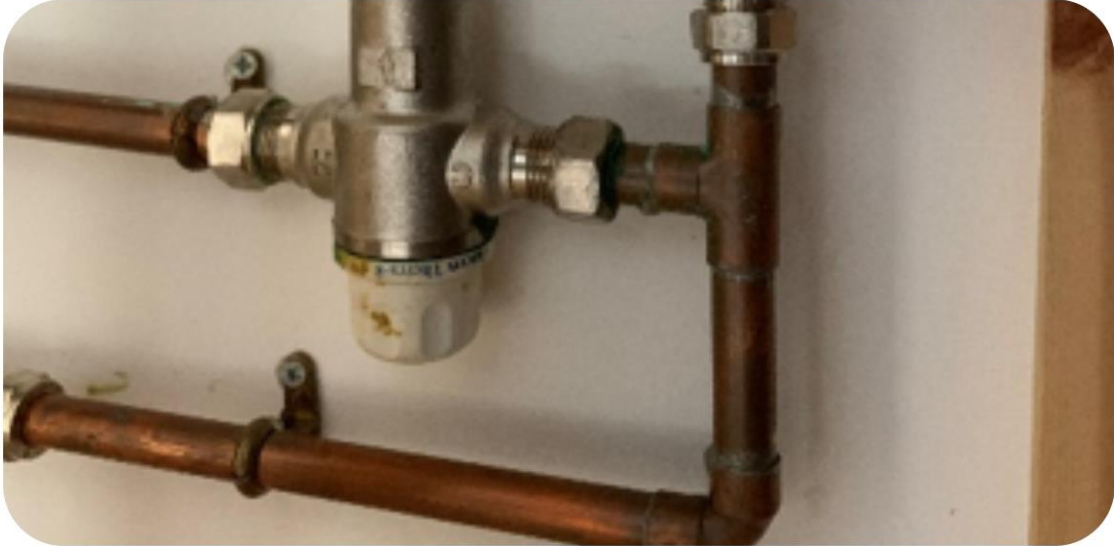
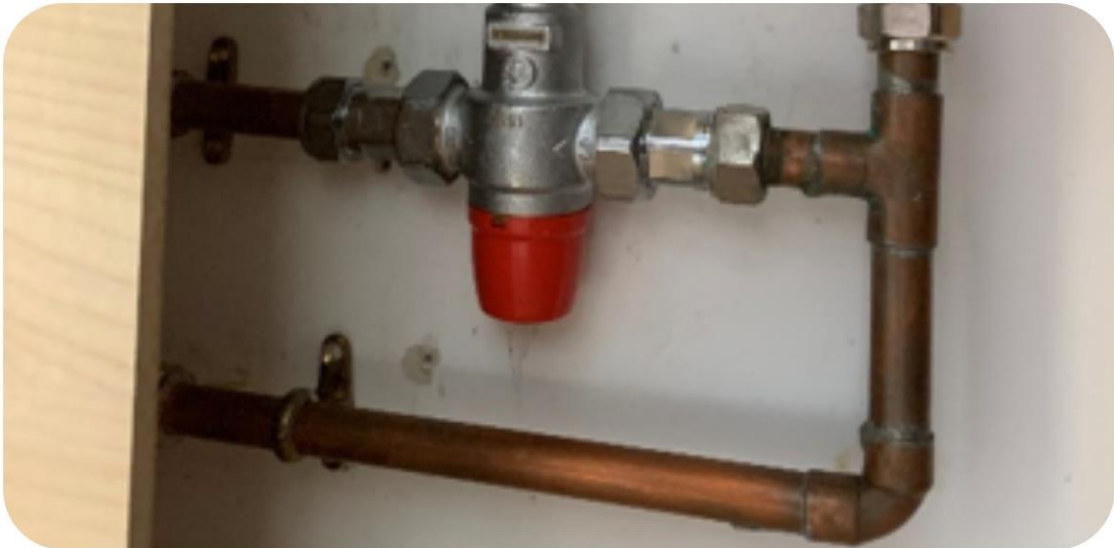
Pre and post picture of a TMV replacement:

- Insulate all hot water pipe work – **Not required – All hot pipework has recently been insulated by others**
- Replace TMV to disabled outlet on ground floor – **Complete**

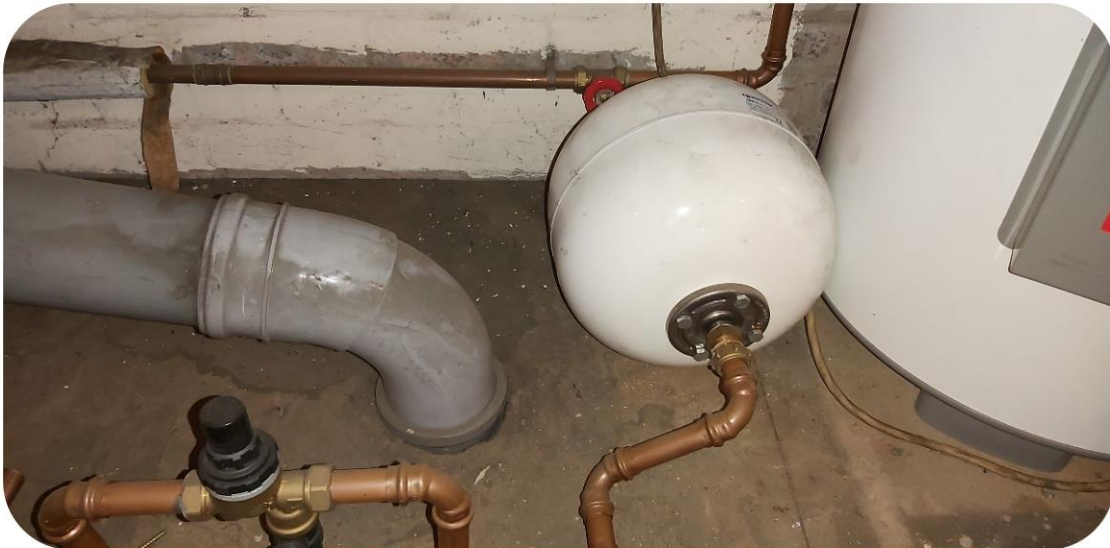
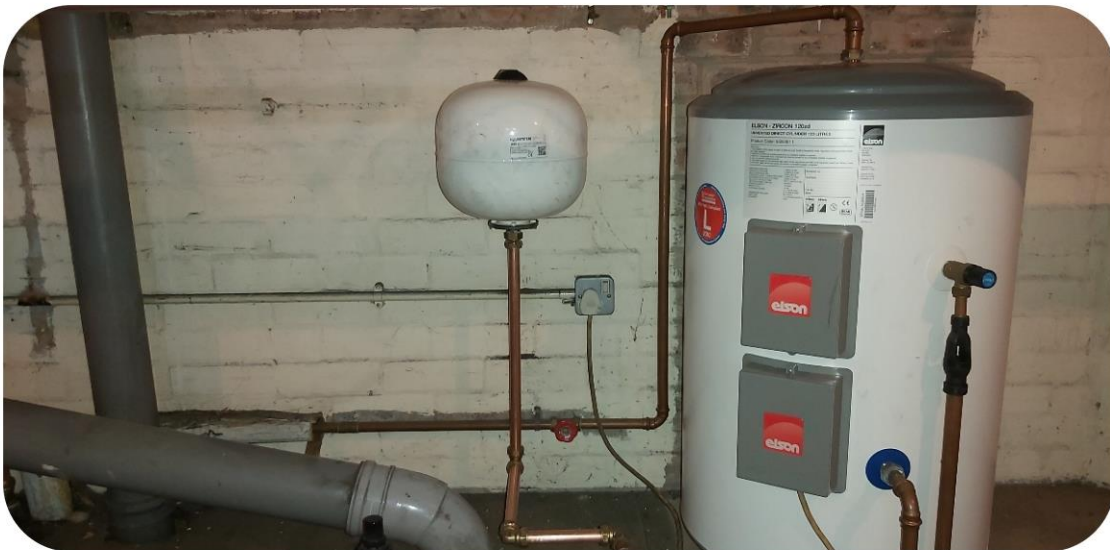
Before and after picture showing the reorientation of expansion vessel:

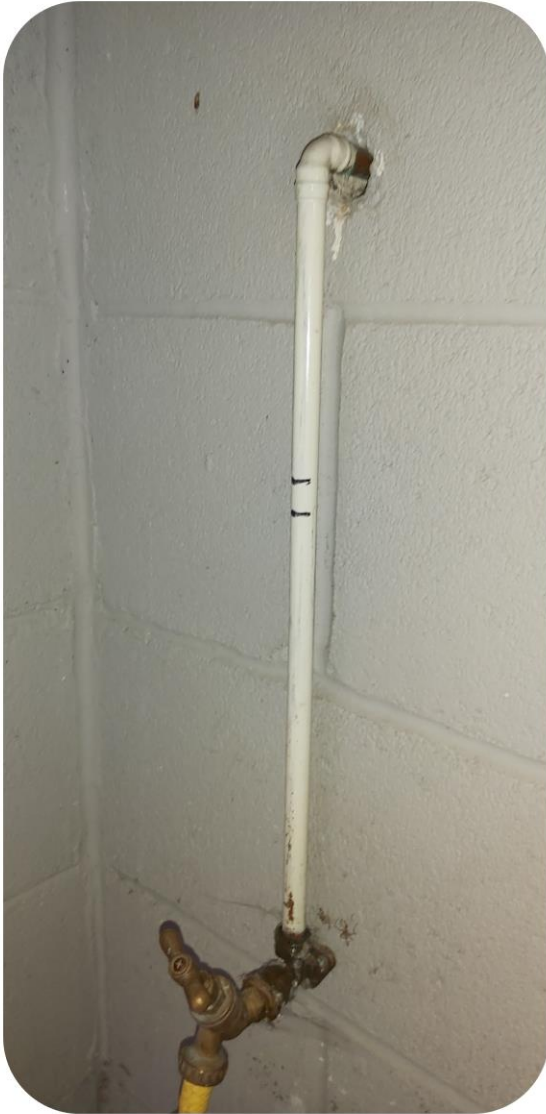
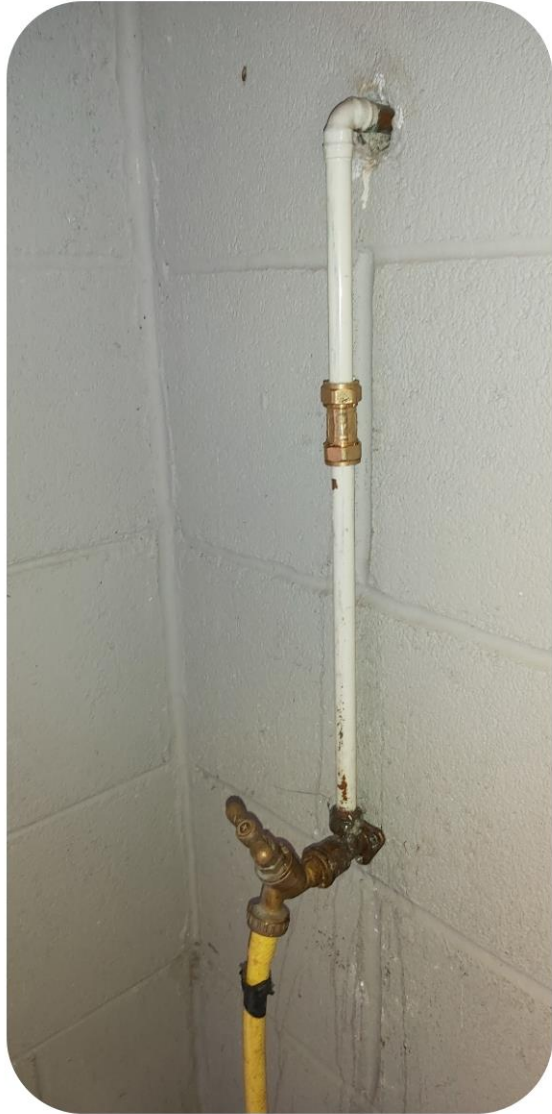
Installation of double check valve on bib tap:

- Big tap Main Building - Ground Floor - Brine Mixer Room - Fit a double non-return valve to the supply pipe - **Complete**

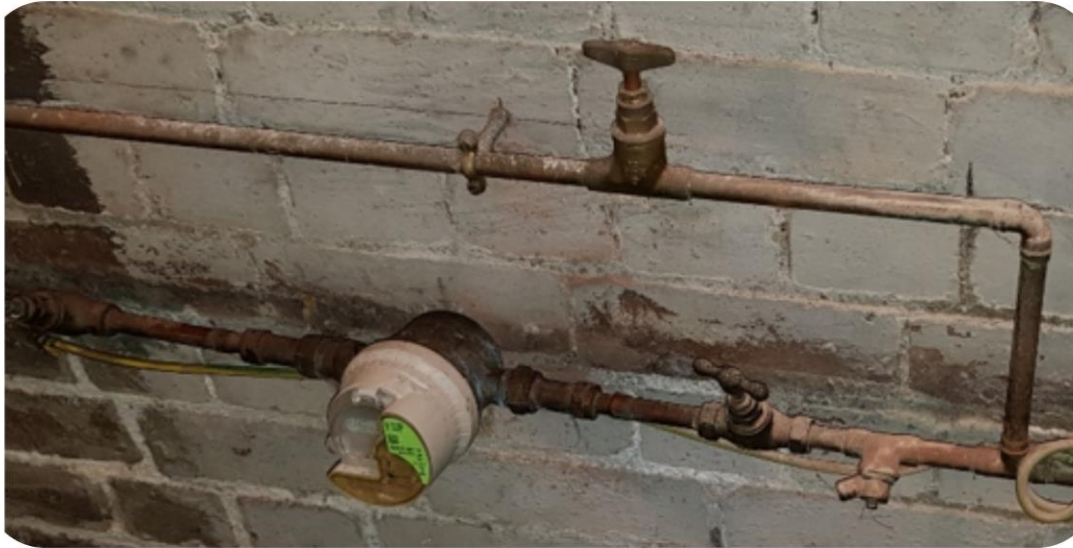
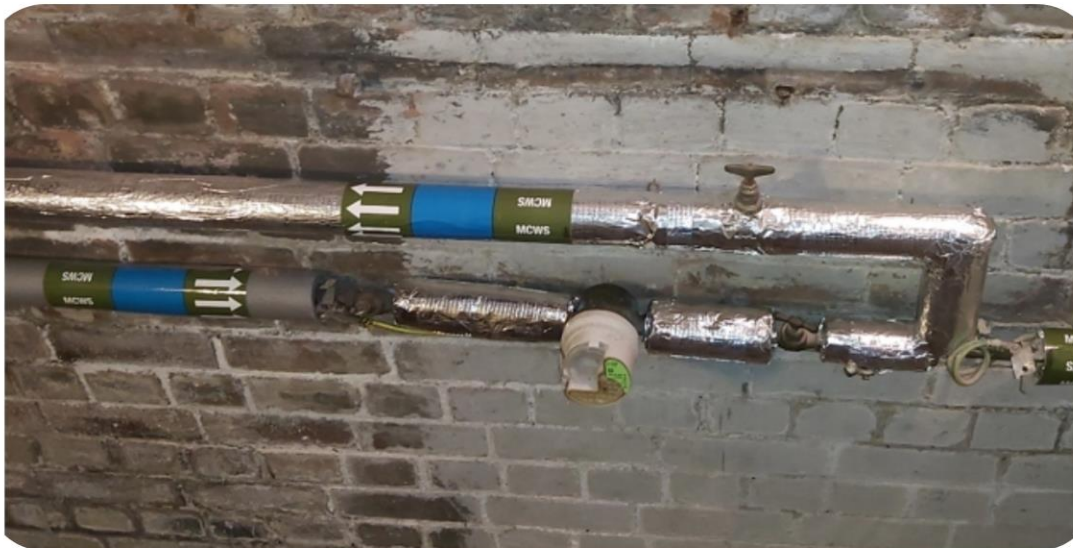
Example of insulation installed to pipework:
