Project Completion Report Reline of Cooling Tower Sump Food Factory - Midlands

Scope of Works: Prepare and reline 1no cooling tower internal sump using a solvent free polyurethane coating.

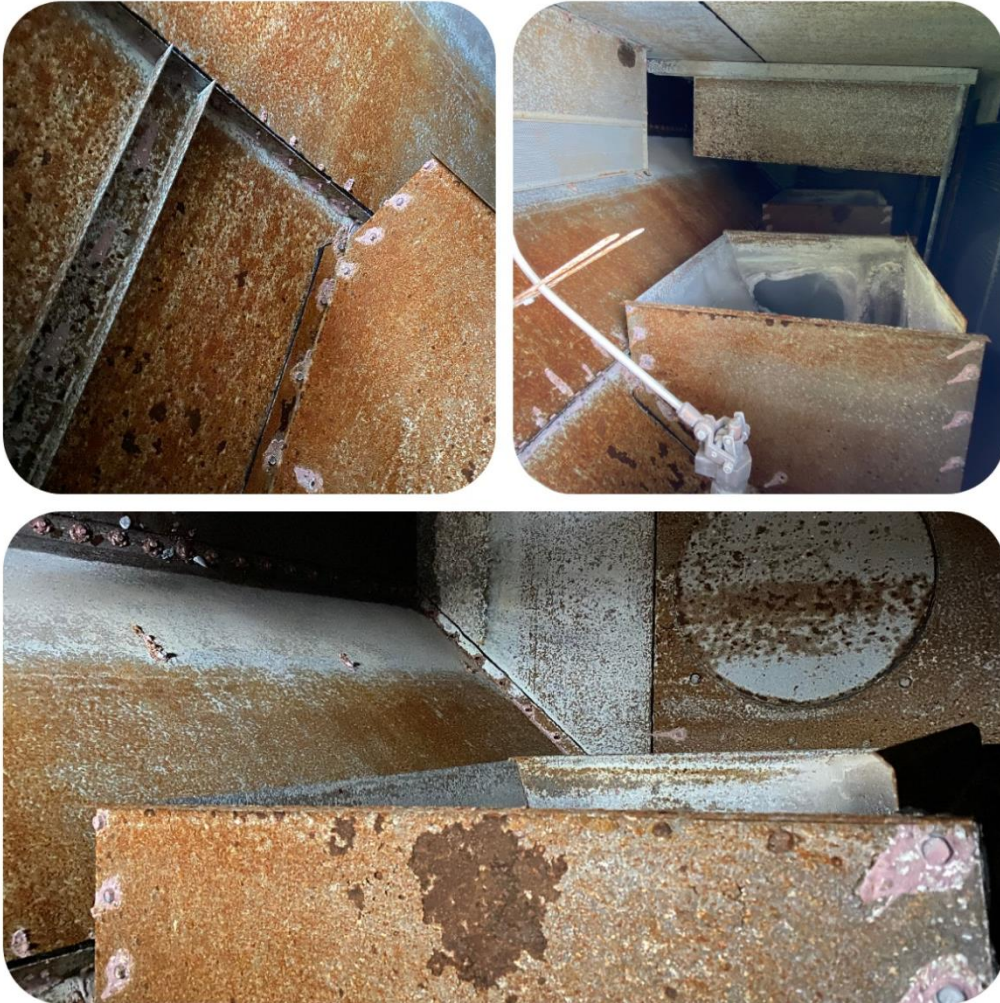
Condition of Sump Prior To Commencement of Works

The cooling tower sump was in poor condition prior to preparation and had heavy internal corrosion along the walls.

- **Arrival** – Cooling Tower Sump was drained and empty on arrival - **Complete**
- **Surface Preparation** – All surfaces of the cooling tower sump were chemically cleaned and mechanically abraded to raise a desired adhesion surface profile of 75 microns. The walls and floors were then washed down with fresh water before a blower was used to dry the surfaces - **Complete**

- **Application of Stripe Coat** – Product was applied by brush to all joints, edges, bolt heads, struts and other sharp protuberances to ensure any high-risk areas are secured and enable subsequent coating to be a seamless membrane - **Complete**

- **Application of First Coat** – Product was applied by roller to internal surfaces to a minimum 500-micron wet film thickness - **Complete**
- **Application of Second Coat** – Product was applied by roller to internal surfaces to a minimum 500-micron wet film thickness to achieve a desired 1000-micron total coating thickness on all internal surfaces - **Complete**

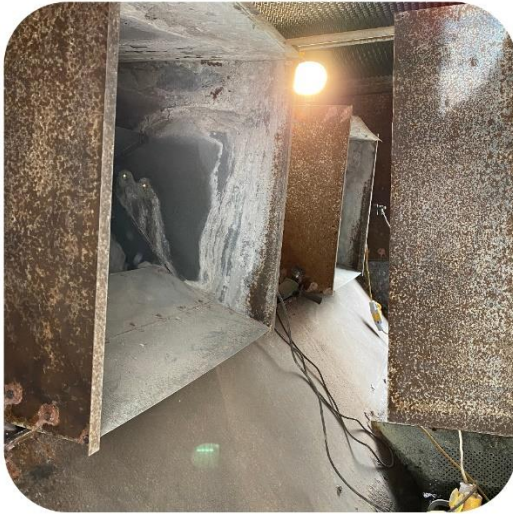
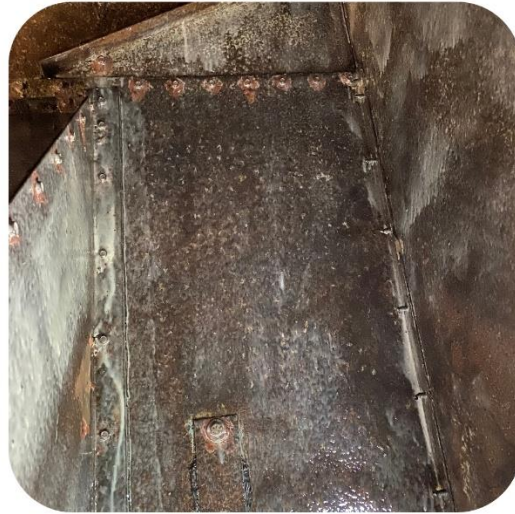
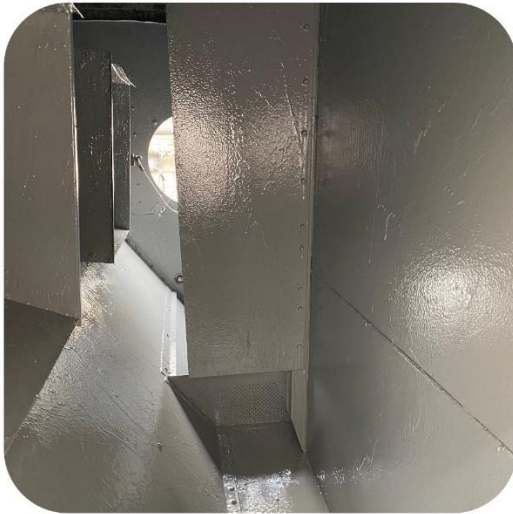
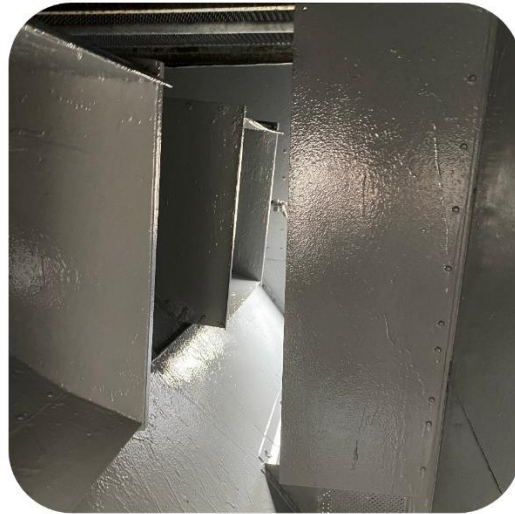
Relining Process

The photos below show the tank at various stages of the process, from preparation of the surface, to the final application of the 1st and 2nd coat. A dry film thickness test was carried out during the process with an average thickness of more than 1000 microns achieved on all surfaces.
