Project Completion Report Installation of Booster Set & Tank Office Block, Surrey

Scope of Works: Installation of new tank fed boosted mains supply including conversion of existing tank fed hot system.

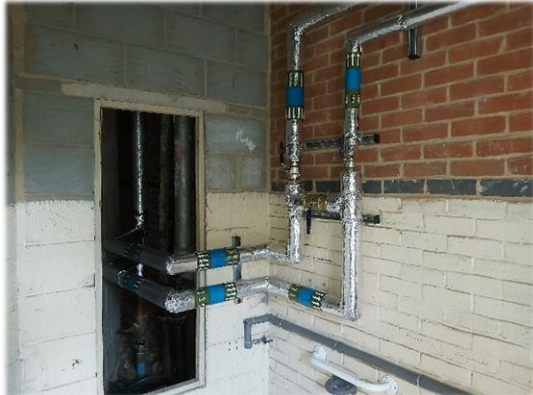
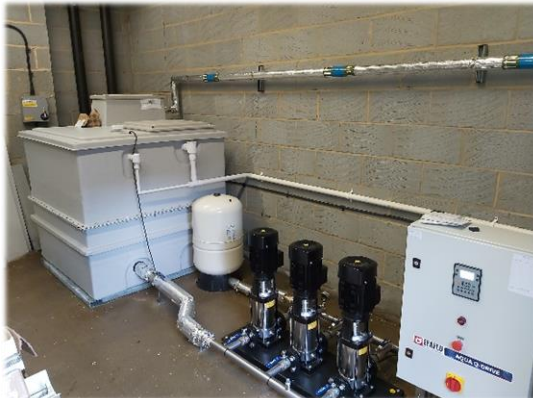
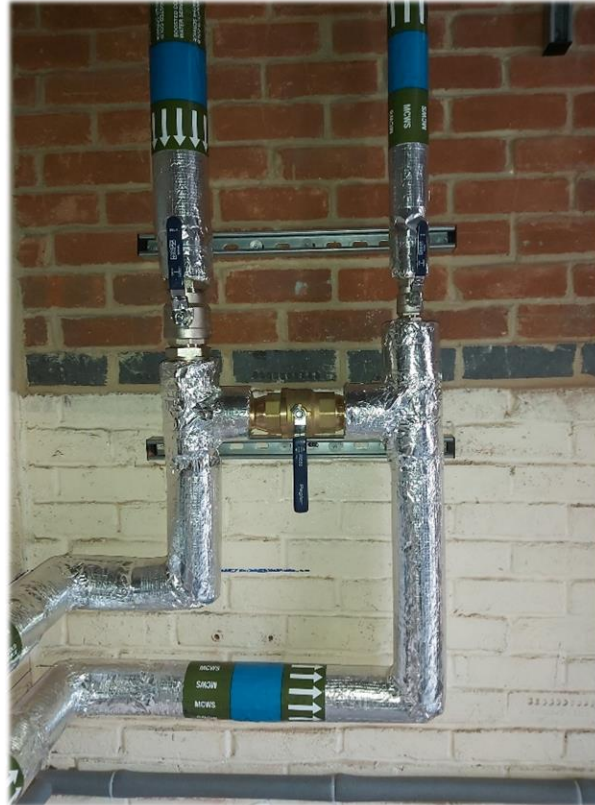
The photos below show the works completed in Phase 1. Installation of new cold water storage tank and booster set.

- **Phase 1:**
 - Install new pipework from incoming mains in plant room and route to the position of the new tank in the opposite storeroom - **Complete.**
 - Install 1no 1800ltr 2-piece GRP tank that will feed the new booster set and down services - **Complete.**
 - Install new foil back insulation, with weather proofing insulation used for external pipework. Label all pipework with BS coding identification - **Complete.**

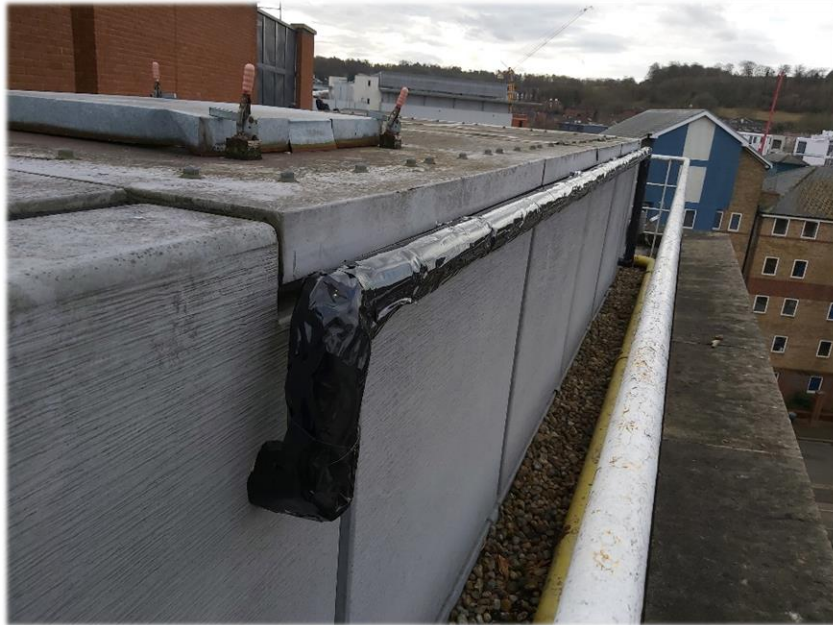
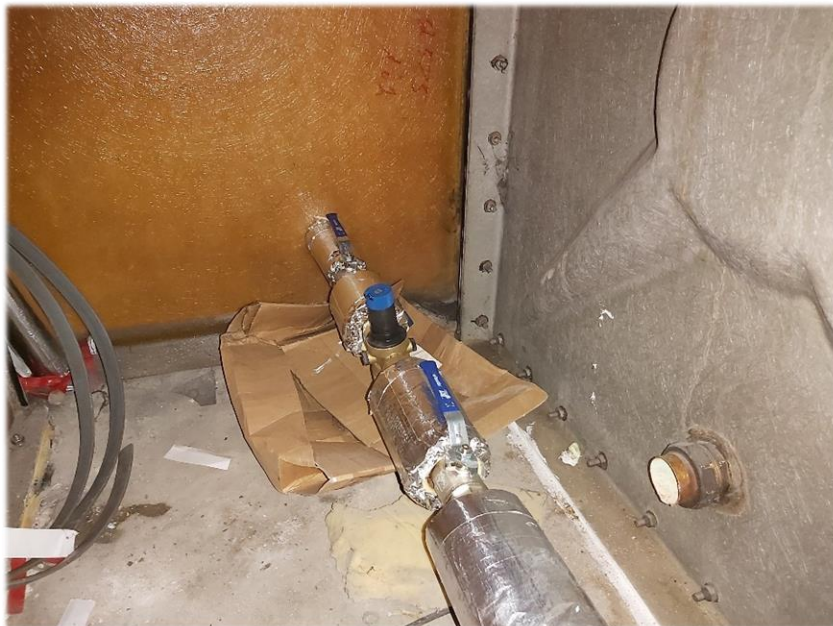
The photos below show the works completed in Phase 2. Bypass and decommissioning of the existing cold water storage tank.

- **Phase 2:**
 - Convert 1x 8000ltr Roof top GRP tank to boosted system - **Complete.**
 - Installation of 1no PRV and associated isolation valves - **Complete.**
 - Install new foil back insulation, with weather proofing insulation used for external pipework. Label all pipework with BS coding identification - **Complete.**

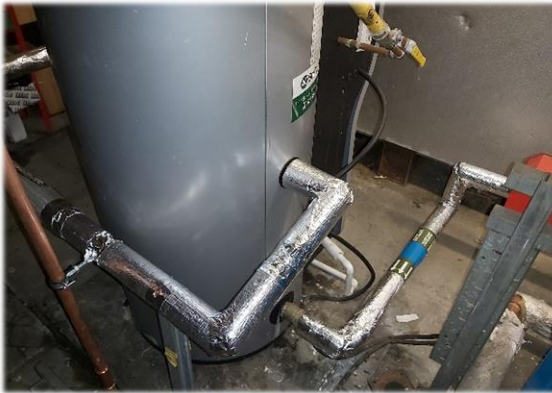
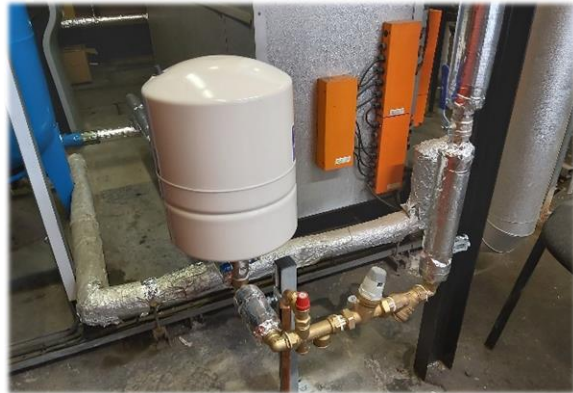
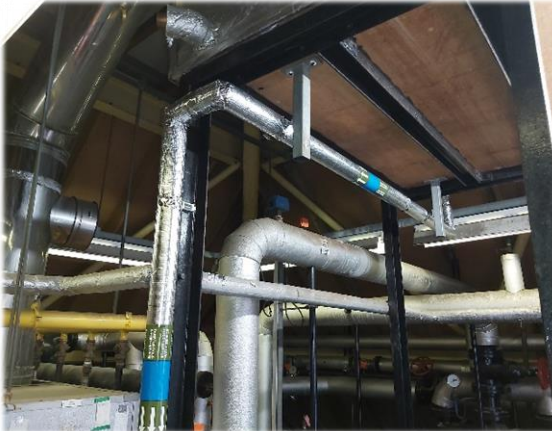
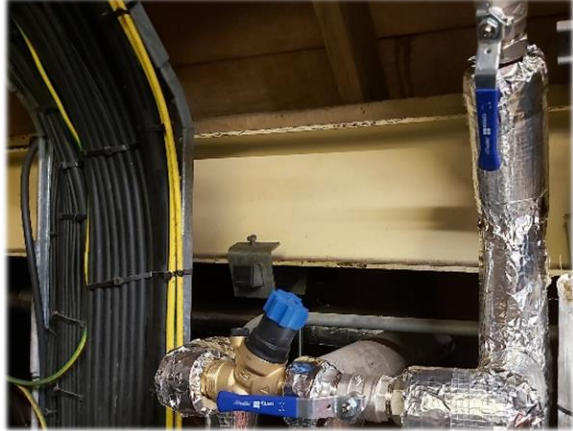
The photos below show the works completed in Phase 3. Mains conversion of the existing tank fed cylinder.

- **Phase 3:**
 - Bypass 1x Plant room CWST and connect to new boosted supply - **Complete.**
 - Installation of 1no PRV and isolation valves - **Complete.**
 - Convert existing hot water cylinder to new boosted main supply. Works include installation of 1no Strainer/1no Pressure relief valve/1no Non return/ 1no flow through expansion vessel and 1no. temperature relief valve - **Complete.**
 - Insulate all pipework with foil back insulation and labelled with BS Coding identification - **Complete.**
